**Evaluation of Corrosion Resistance of New and Upcoming Post-Tensioning  
Materials After Long-Term Exposure Testing**

**Thesis**

The University of Texas at Austin

**December 2010**

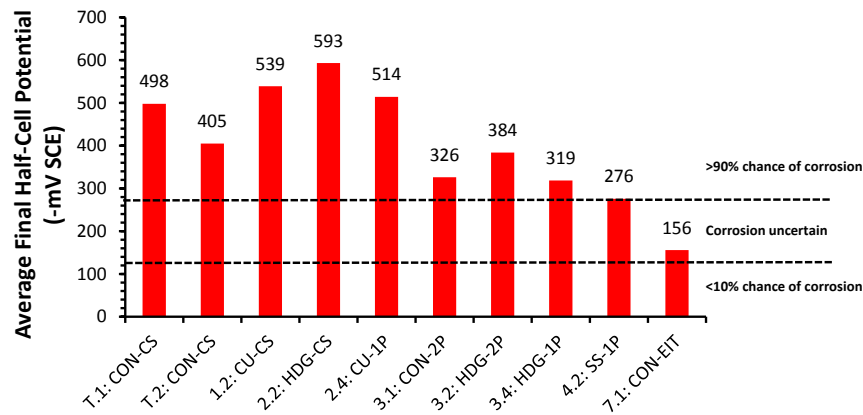
**Figure 4.2: Average Final Half-Cell Readings**

Specimen 2.2 had the most negative final average potential, while specimen 7.1 had the least negative potential. This probably indicates the effectiveness of the electrically isolated system used in specimen 7.1. Specimens with galvanized steel ducts had an average final half-cell potential of  $-509 \text{ mV}_{\text{SCE}}$ , while those with plastic ducts had an average final potential of  $-329 \text{ mV}_{\text{SCE}}$ . This suggests that specimens with plastic ducts had less corrosion at the time of autopsy. Average final potential for specimens with conventional strand was  $-346 \text{ mV}_{\text{SCE}}$ , while the average for specimens with any other type of strand was  $-437 \text{ mV}_{\text{SCE}}$ , indicating that the specimens with conventional strand were actually less corroded than the specimens with novel strand types at autopsy. This seems highly counterintuitive but can be explained. Averaging the final readings in this manner ignores the individual contributions of each element to corrosion. The higher potentials of the specimens with novel strand types may have occurred due to a higher

degree of corrosion in the specimens' reinforcing steel or ducts. Also, different types of strand are likely to corrode in ways which produce different potentials. Analysis of the final half-cell potentials alongside the results of the forensic analysis will shed more light on the corrosion within each specimen.

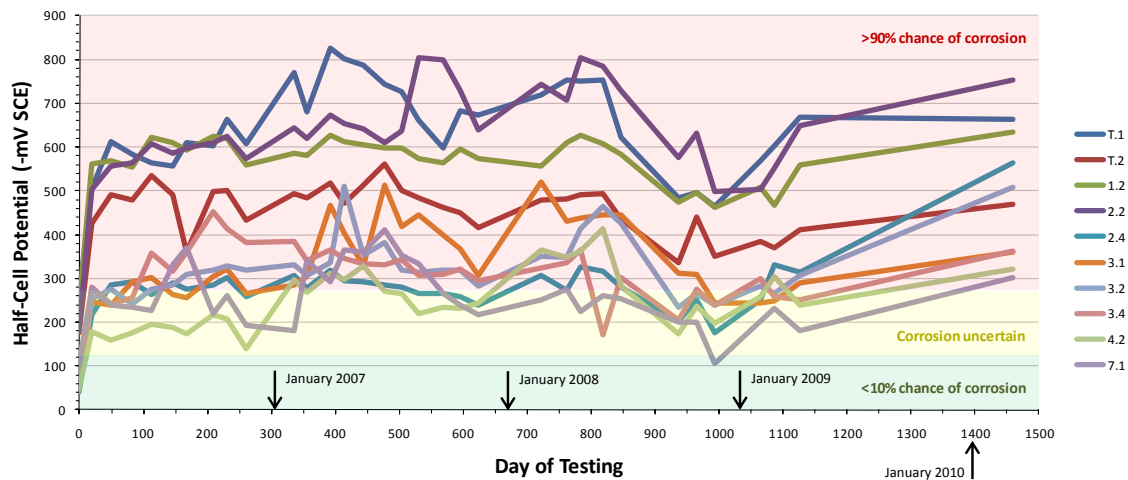
**Figure 4.3: Maximum Monthly Half-Cell Potentials**

From the plot of all maximum monthly readings, it appears that the most negative monthly potentials for most specimens were within the uncertain or greater than 90% probability of corrosion range for nearly the entire exposure period. Maximum readings increased quickly at the beginning of exposure, then appeared to fluctuate loosely around a mean value for each specimen. Potentials for many specimens became noticeably less negative between approximately 800 and 1000 days of exposure. Very negative but consistent potentials indicate that corrosion is electrochemically probable but limited by a lack of oxygen<sup>14</sup>. However, no specimen shows uniform readings over its entire life, suggesting that oxygen was never a limiting factor in corrosion for any specimen.

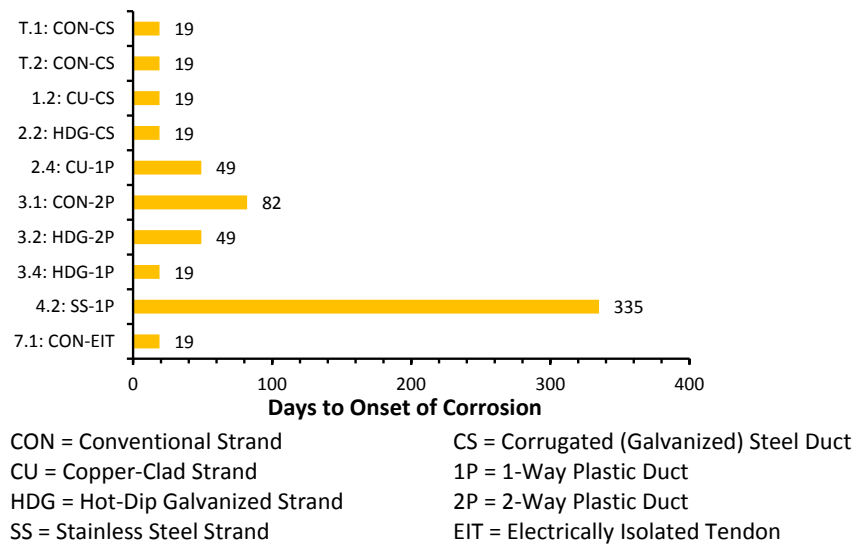
**Figure 4.4: Estimated Time to Initiation of Corrosion**

By this estimate, corrosion began almost immediately for most specimens; 19 days corresponds to the first half-cell reading after exposure began. The four specimens with galvanized steel ducts had a combined average time to corrosion initiation of 19 days, while the six specimens with plastic ducts averaged 92 days. This indicates that specimens with galvanized

ducts began to corrode before those with plastic ducts. Among the four specimens with conventional steel strand, the average time to corrosion was 35 days, compared to an average of 82 days for all other types of strand. The only marked difference was with Specimen 4.2, which contained stainless steel strand. Half-cell potential readings indicated that corrosion did not initiate in that specimen for nearly a year after exposure began. This indicates that stainless steel strand is much more corrosion-resistant than the other types studied in this phase of autopsies. Just as in the analysis of the average final half-cell readings, it should be noted that averaging the estimated time to corrosion in this manner ignores the individual contributions of each element to the total corrosion of the specimen. In Chapter 6, half-cell potentials are compared to the results of the forensic analysis. This will illustrate the accuracy of the half-cell method as it was implemented on this project.

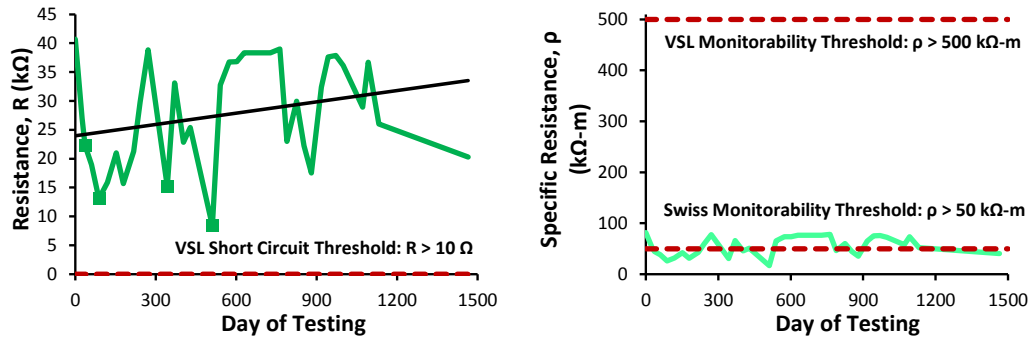
**Figure 4.5: Resistance and Specific Resistance for Specimen 7.1**

In general, the resistance increased throughout the test period, as shown by the trendline in Figure 4.5. This is normal behavior, as resistance tends to increase with age<sup>4</sup>. VSL defines the minimum resistance required to assure the absence of a short circuit to be 10  $\Omega$ . All resistance measurements easily exceed this value. Thus, it is reasonable to assume that no short circuit occurred between the tendon and reinforcing steel. VSL also defines a threshold specific resistance of 500  $\text{k}\Omega\text{-m}$ , below which a post-tensioning tendon is not considered monitorable in the long term<sup>4</sup>. All of the specific resistance values were well below this value, suggesting that the tendon is not suitable for accurate long-term monitoring. However, ASTRA (Swiss Federal Road Office) gives a much lower threshold for monitorability of 50  $\text{k}\Omega\text{-m}$ <sup>18</sup>. Approximately 60% of the specific resistance values for Specimen 7.1 were above this threshold. The Swiss standard is several years newer than that which was published in FIB Bulletin 33. The specific resistance threshold was reduced after field experience showed that 500  $\text{k}\Omega\text{-m}$  was nearly unattainable in the field<sup>19</sup>. Regardless of which standard is used, the monitorability of Specimen 7.1 is in question.

Low resistance values can indicate an electrolytic connection between tendon and concrete. A decrease in resistance of 30% or more indicates that moisture has entered the duct<sup>4</sup>. A decrease of this magnitude occurred four times throughout the life of Specimen 7.1. These points are marked with squares on the plot of resistance versus time (see Figure 4.5). While there was no direct electrical contact between tendon and reinforcement, a leak may have allowed chloride ingress at one or more points along the duct, causing the resistance to drop. However,

since resistance readings were not uniform over the life of the specimen, these four decreases could be merely scatter.

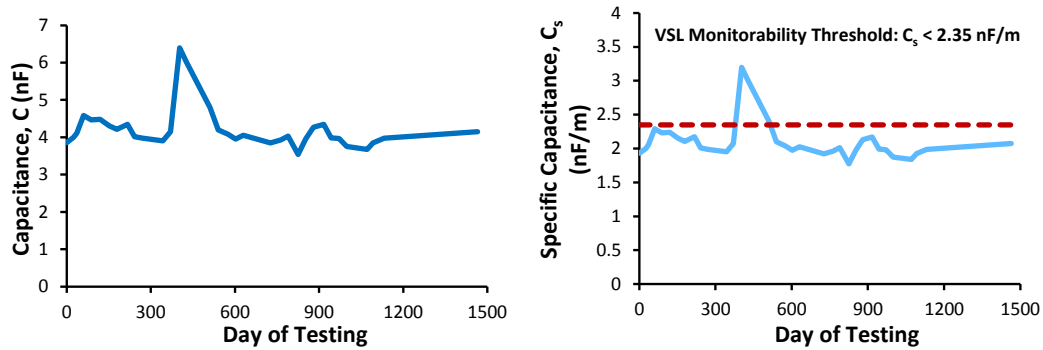
**Figure 4.6: Capacitance and Specific Capacitance for Specimen 7.1**

The VSL maximum specific capacitance for monitorability is  $2.35 \text{ nF/m}^4$ . All but two measured values were below this threshold, indicating that the specimen is mostly monitorable. The Swiss document gives no guidelines for specific capacitance values.

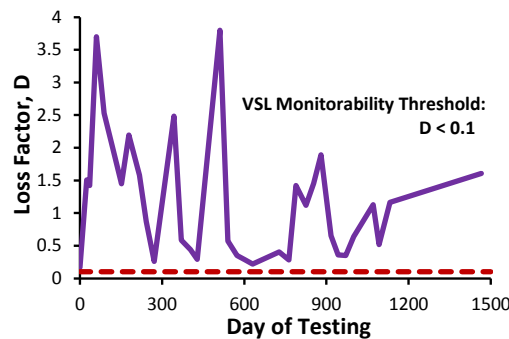
**Figure 4.7: Loss Factor for Specimen 7.1**

The VSL minimum threshold for the loss factor is  $0.1^4$ . All measured values were greater than this, indicating that the tendon is not monitorable. The Swiss document does not mention loss factor values.

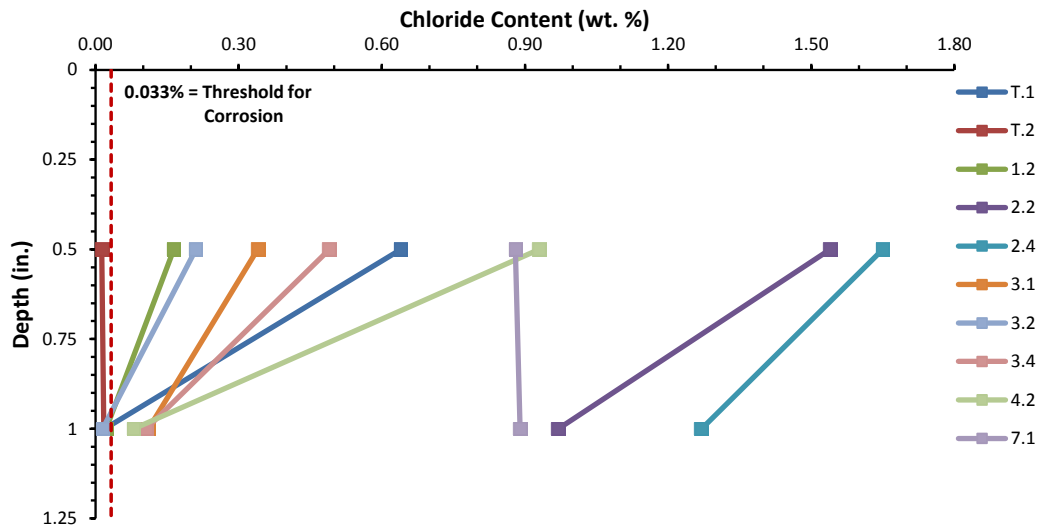
*Figure 4.8: Specimen Chloride Content at Top Surface, 2-Inch Offset*

Chloride content decreased with depth for all specimens except for Specimen 7.1. It is possible that the presence of additional indentations within that specimen's saltwater tray caused a chloride distribution in which concentrations were actually higher at 1 inch depth than at 0.5 inches. At a depth of 0.5 inches, chloride content was well above the corrosion threshold for every specimen except for T.2. At 1 inch depth, chloride content was above the threshold for six of the ten specimens.

The high level of chlorides within the top surface of the specimens may indicate one of two things. Either the concrete was relatively porous and allowed chlorides to permeate to a depth of at least one inch, or several samples were inadvertently extracted from a small crack. The former is certainly plausible. The surface of the specimens' saltwater trays generally appeared to be in poor condition upon autopsy, and the subsurface concrete condition could have been affected as well. The latter case is also possible, although care was taken to examine the drilling site prior to extraction to ensure that no visible cracks were present there. Had control blocks been cast alongside the post-tensioned specimens at the start of the project, there would be a better understanding of the transport of chlorides through the concrete.

Exposure procedures had not been strictly followed for at least one year prior to autopsy. This most certainly affected the chloride distribution in the concrete under the saltwater tray of each specimen. Regardless, the presence of large, deep cracks on the top of all specimens increases the probability of corrosion substantially. Because chlorides can travel so deep into the specimens through the cracks, their movement through the pore space of the concrete is expected to have a nearly negligible effect on corrosion.

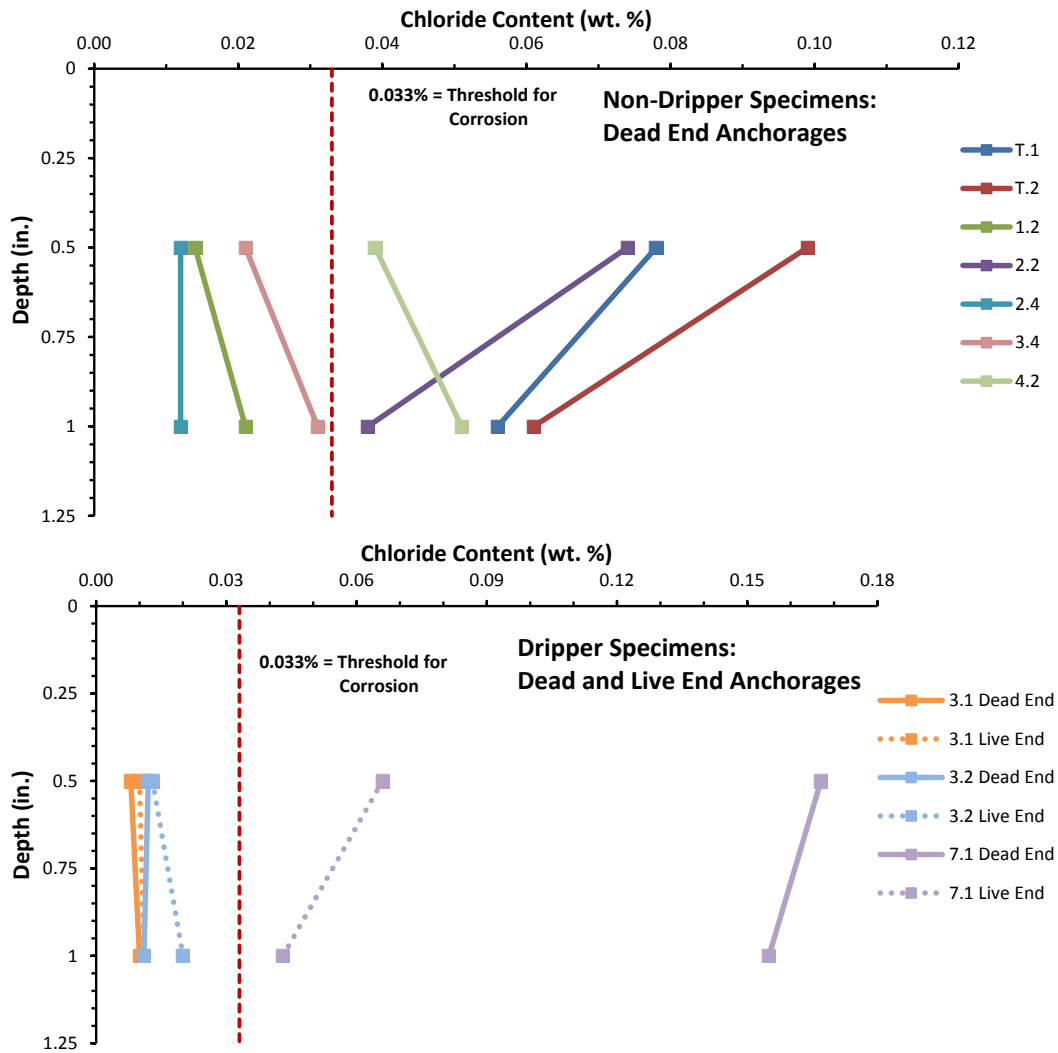
**Figure 4.9: Specimen Chloride Content at Anchorages**

Overall, concentrations were much lower at the dead end anchorages than at the top surfaces of the seven non-dripper specimens. Maximum chloride content for any non-dripper specimen was 1.65% (Specimen 2.4) at the top surface and 0.099% (Specimen T.2) at the dead end anchorage. Three of the seven non-dripper specimens showed chloride concentrations below the corrosion threshold at both depths. The other four specimens were above the threshold at both depths. In addition, chloride content only decreased with depth for three specimens.

Chloride content was below the corrosion threshold at the live and dead ends of dripper specimens 3.1 and 3.2. The concentrations also increased with depth at both ends for these

specimens. For Specimen 7.1, chloride content decreased with depth and was above the corrosion threshold at both ends. In addition, concentrations decreased with depth for this specimen. For the exposure specimens, anchorage region concentrations were much lower in magnitude than top surface concentrations.

For all specimens, the pourbacks were visually in much better condition upon autopsy than the saltwater trays. Therefore, concrete permeability should not have played a role in the unusual chloride distributions seen in Figure 4.9. Additionally, care was taken to avoid extracting a sample from a crack, thus negating the effects of accumulated chlorides within the pourback cracks. Anchorage chloride levels may have increased in the dead ends of all specimens and the live ends of the dripper specimens due to overflow which occurred when saltwater was flushed from the specimens' saltwater trays each month. It is important to note that there is a full order of magnitude difference between top surface chloride concentrations and the anchorage chloride concentrations. The strange distributions visible in Figure 4.9 could be partially caused by inaccuracies of the testing equipment at lower chloride contents. Regardless of the explanation, the accuracy of chloride concentrations as a predictor of internal corrosion will be examined in Chapter 6.

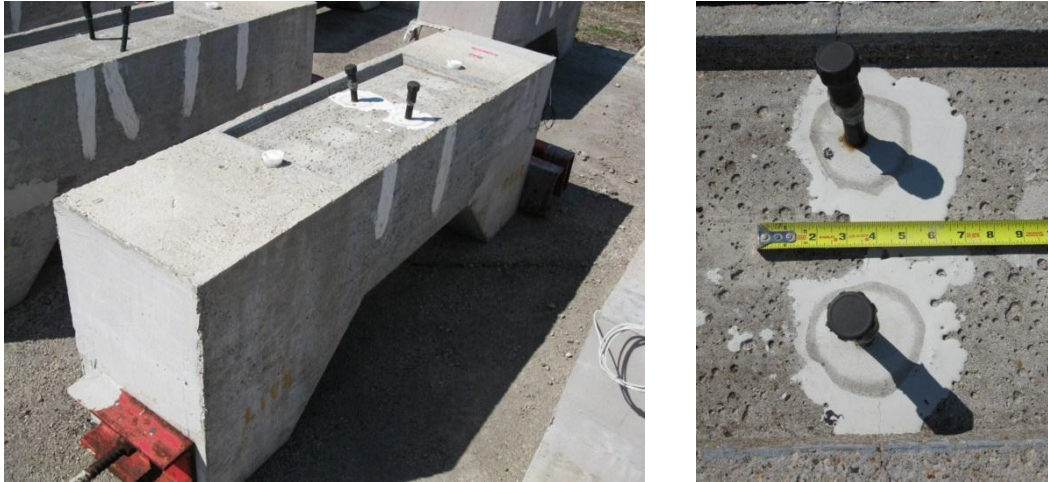
*Figure 5.14: Specimen T.1 Overall (Right) and Grout Vents (Left)*

The exposed surfaces of the concrete showed some moderate scaling. Large aggregate was visible at many locations, especially along the specimen's edges. The surface of the saltwater tray had many shallow air voids which had developed during casting. Two approximately 6-inch-diameter hardened grout puddles were present around the vents, indicating overflow during the grouting process. A small amount of staining was visible around the base of the north grout vent, suggesting the presence of corrosion inside the specimen. This is shown in Figure 5.14.

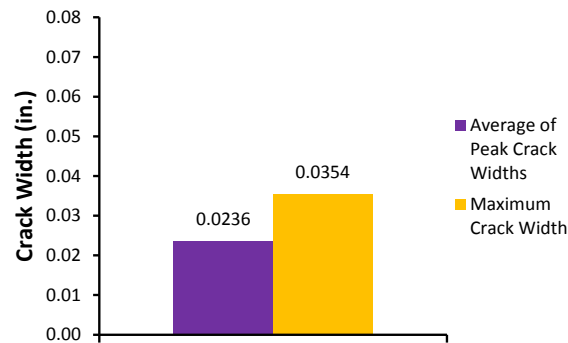
**Figure 5.15: Specimen T.1 Crack Data**

The specimen had two large transverse cracks running across its top face, each with an average width of 0.03 inches. These cracks extended down the north and south faces of the specimen. The epoxy used to seal the cracks on these faces was intact. There was one longitudinal crack with an average width of 0.004 inches running perpendicular from the north grout vent to the transverse crack near the live end of the specimen. A large crack had formed at the re-entrant corner of the dead end corbel during live load application<sup>7</sup>. This crack had been sealed with non-shrink mortar which appeared intact during inspection. The dead end anchorage pocket pourback showed significant separation from the surrounding concrete at its construction joint. In addition, the entire dead end and top surfaces of this pourback displayed moderate pattern cracking, suggesting that some shrinkage occurred after the mortar was placed. Crack width data is shown in Figure 5.15, and the crack diagram is shown in Figure 5.18.

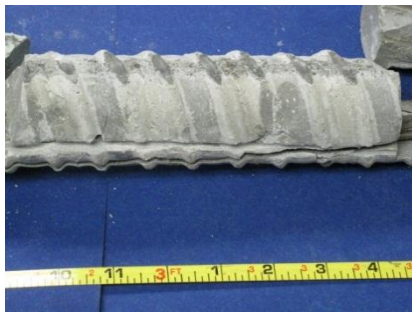
**North Grout**

The north tendon grout had very few discernible transverse cracks and no longitudinal cracks. Corrosion staining could be seen near midspan and the live end quarter point, coinciding with the corrosion observed in the duct at those locations. Orange-yellow staining was also visible at seemingly random points along the grout. Small, elliptical, uniformly-sized voids approximately 0.75 inches in width were found along nearly the entire length of grout. These voids formed in and around the uppermost flutes of the duct, as shown in Figure 5.17. Chloride content varied little within the north duct grout. Maximum chloride content was 0.085% at midspan, well above the corrosion threshold.

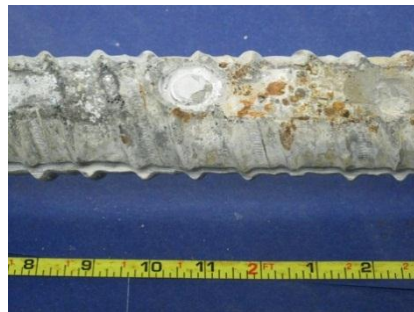
**South Grout**

The south duct grout also had very few discernible transverse cracks and no longitudinal cracks. Corrosion staining was present near the grout vent at midspan and at both quarter points. Faint, yellow-colored staining was found in patches over nearly the entire length of grout. Voids, approximately 1 inch in width, and continuous bubbling were found on the top side of the grout. These occurred mostly within flutes of the duct, over most of the duct's length. The largest void occurred just towards the dead end from midspan (see Figure 5.17). This void was approximately 1.5 inches across and continuous across several duct flutes. Chloride content was 0.083% at 25 inches from the live end and 0.058% at both 10 inches and 33 inches. Chloride content for grout in both tendons is shown in Figure 5.18.

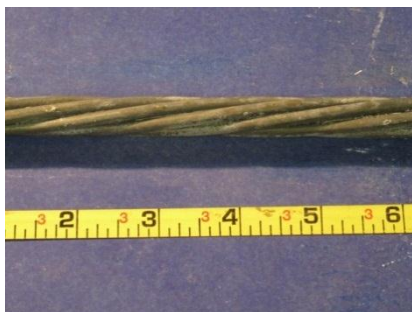
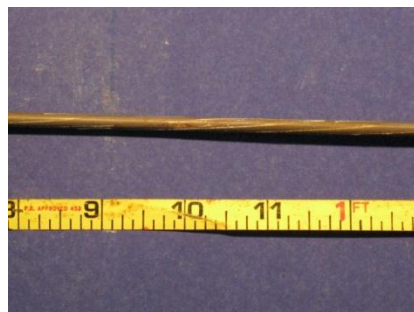
The three strands in the north tendon suffered only minor damage. Discoloration was present on some of the outer wires on many intervals, and just a few intervals experienced small flecks of light corrosion. The inner wires were more damaged, with light corrosion present on nearly all intervals. Corrosion ratings were uniform over the entire tendon, and all corrosion could be removed with a scouring pad.

The strands in the south tendon were somewhat more severely affected. On the outer wires, discoloration and light corrosion were present on many intervals. Corrosion which could not be scoured off occurred at a few points along each strand. The inner wires had light corrosion spots on almost all intervals. Corrosion ratings were mostly uniform over the entire tendon, although strand corrosion ratings were higher for the south tendon than for the north. A typical strand and inner wire are shown in Figure 5.17. Strand corrosion ratings are shown in Figure 5.18 and are summarized in Table 5.5.

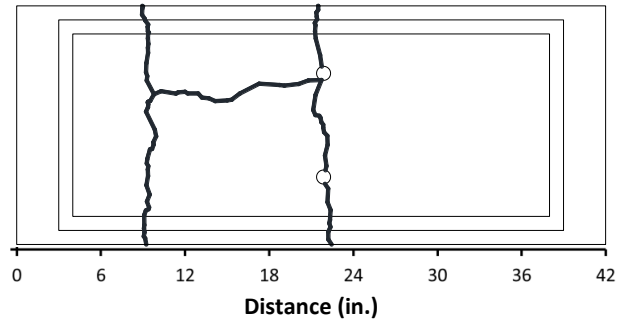
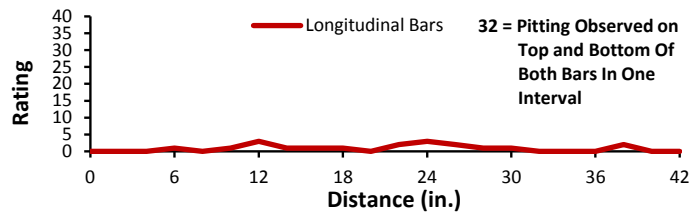
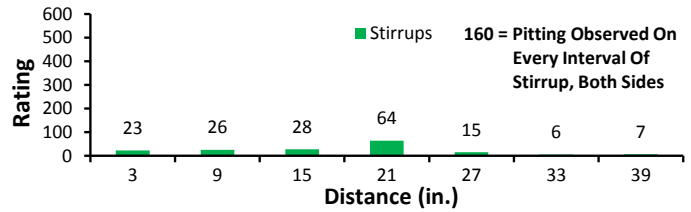
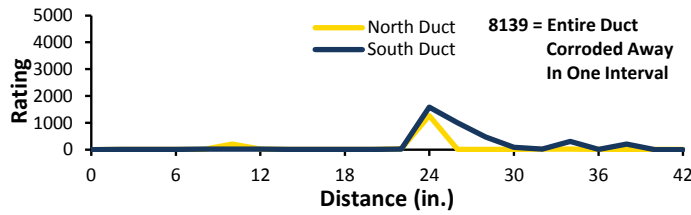
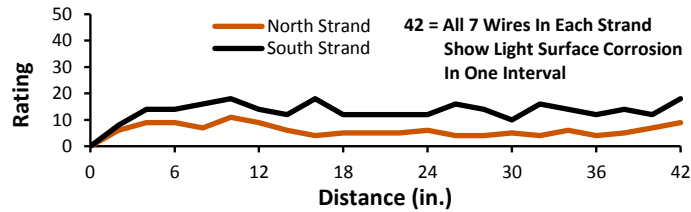
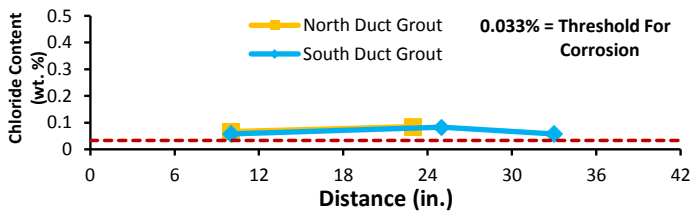
Figure 5.18: Specimen T.1 Crack Map and Corrosion Rating Plots

While chloride concentrations were above the corrosion threshold at every measurement point in both tendons, the measurements were relatively uniform. This suggests that chlorides

passed down through the cracks to duct level at the same rate, and that corrosion initiated at approximately the same time across the duct. There was no area loss in the north duct at 9 inches from the live end. However, chloride content was above the corrosion threshold at this location. This suggests that chlorides entered the duct through the area loss at midspan and traveled along the duct either through the top voids in the grout or through the interstices of the strands. Either scenario is possible, although the small number of cracks in the grout suggest that the chlorides traveled through the voids.

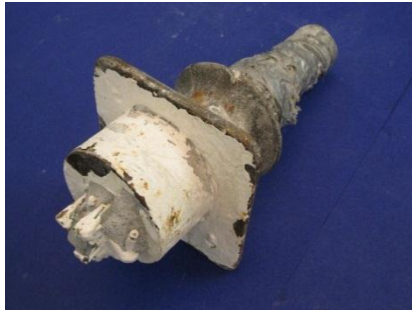
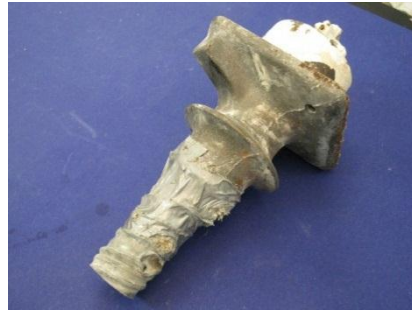
***Figure 5.19: Specimen T.1 Anchorages and Anchor Heads***

The epoxy applied to the anchorages prior to the pourback was mostly intact upon autopsy. North and south bearing plates and anchor heads had widespread light corrosion and discoloration on all epoxied surfaces. The outer surfaces of the bearing plates were mostly corrosion-free. Some light to moderate corrosion occurred on the edges and undersides of both bearing plates. The duct tape used to seal the bearing plate-duct connection was intact on both anchorages. Extensive surface corrosion was found on the surfaces covered by the duct tape. Upon removal, the anchor heads were completely intact but had widespread discoloration and some localized corrosion spots. The north and south anchorages and anchor heads are shown in Figure 5.19.

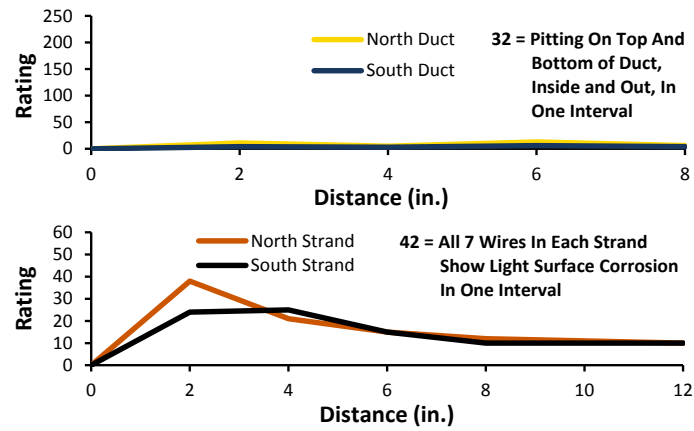
*Figure 5.20: Specimen T.1 Anchorage Corrosion Rating Plots*

Both north and south anchorage zone ducts experienced pitting and corrosion near their splice zone, where they had been wrapped in duct tape. Some localized corrosion and discoloration were found elsewhere on the ducts' outer surfaces. Inside, the ducts were widely discolored, and some pitting and corrosion were found in the uppermost flutes of the ducts. This damage seemed to coincide with the locations of voids. North and south anchorage zone ducts are shown in Figure 5.21. Corrosion ratings for the anchorage zone ducts are shown in Figure 5.20 and are summarized in Table 5.6.

The strands in both the north and south tendons experienced light localized corrosion and discoloration scattered across their lengths. As with the main specimen tendons, the center wire of all strands was slightly more damaged than the outer wires. Damage to both sets of strands was most severe at the ends which were outside the anchor head. One strand in each duct experienced moderate corrosion on several wires in its outermost interval. All wedges were substantially intact with only light localized corrosion. The appearance of a typical strand, with and without wedges, is shown in Figure 5.21. Corrosion ratings for the anchorage zone strands are shown in Figure 5.20 and are summarized in Table 5.6.

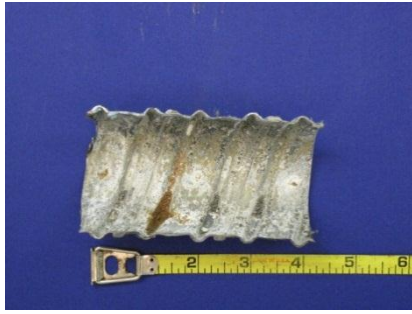
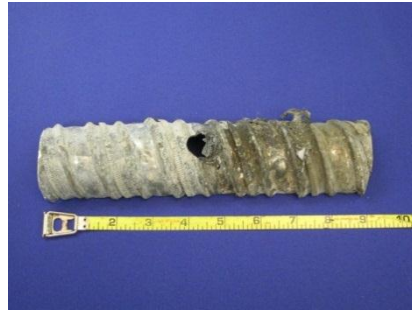
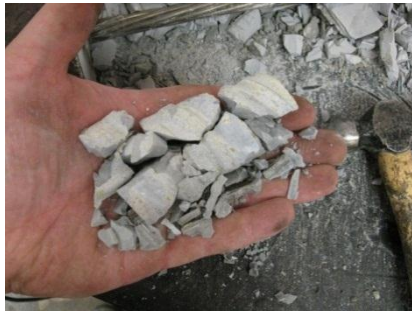
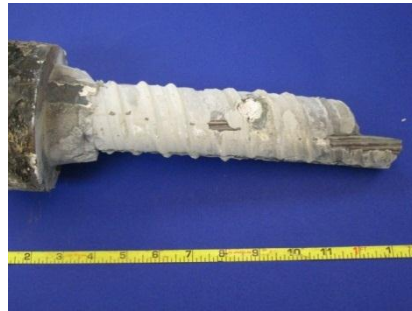
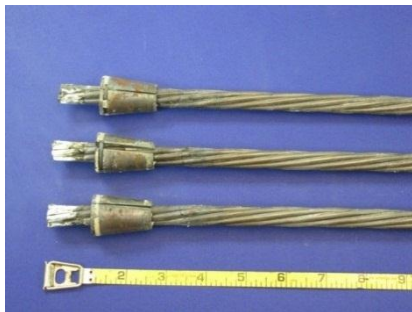
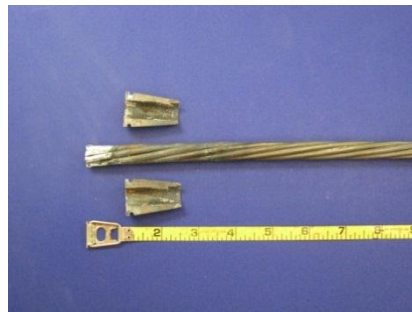
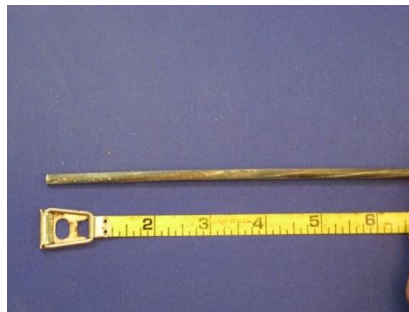
**Figure 5.21: Specimen T.1 Anchorage Region Elements**

The north grout broke apart during removal. It was impossible to discern the extent of its cracking. Many small, yellowish flecks were found on the outer surface of the grout. Small, elliptical, bubble-filled voids were found on the top surface of both the north and south grout, corroborating the evidence of voids found inside the north and south ducts. The south grout showed no signs of corrosion on its outer surface. Moderate segregation occurred over the length of the anchorage zone. The grout was a light gray color near the anchorage itself and became darker moving into the specimen. North and south tendon grouts are shown in Figure 5.21.

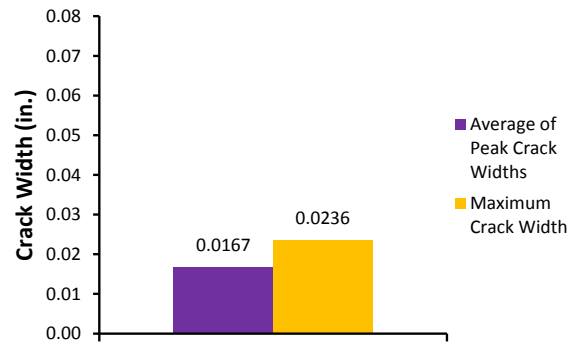
**Figure 5.24: Specimen T.2 Crack Data**

The specimen had two large transverse cracks running along its top face and down its north and south faces, each with an average width of 0.03 inches. The epoxy used to seal the vertical portions of these cracks to prevent leakage was intact. The transverse crack nearest to the dead end was not continuous across the specimen. One discontinuous longitudinal crack was present approximately 6 inches from the south face of the specimen. Its maximum width was 0.01 inches. This crack was not continuous. It was not visible within about six inches of the south grout vent. Similar to specimen T.1, a large crack had formed at the re-entrant corner of the dead end corbel during live load application<sup>7</sup>. This crack had been sealed with non-shrink mortar, which was still intact at the time of autopsy. The dead end anchorage pourback showed significant separation as well as some delamination near its interface with the rest of the specimen. This is shown in Figure 5.23. In addition, pattern cracking was found on the top and dead end surfaces of the pourback. This suggests the action of plastic shrinkage during the life of the specimen. Crack width data is shown in Figure 5.24, and the crack diagram is shown in Figure 5.28.

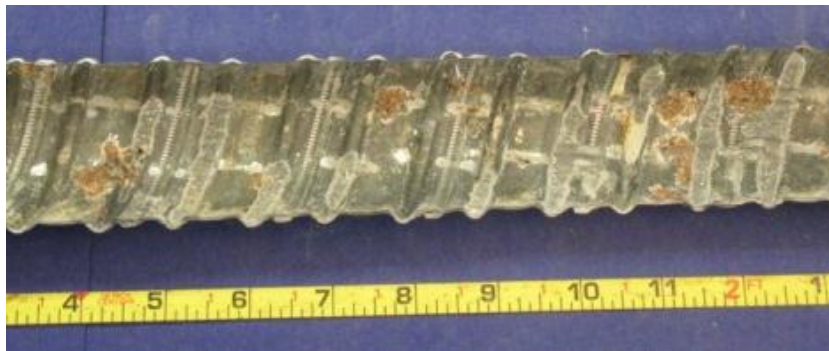
***Figure 5.25: Specimen T.2, Corrosion Along Gouges on Bottom Half of North Duct***

was more severe on the inside of the duct than the outside. The overall shape of the area loss and pitting inside the duct indicates the presence of a very large void extending over most of the duct's length. The bottom portion of the north duct was less damaged. Inside, there was widespread discoloration and light localized corrosion, mostly occurring on the same intervals as the area loss on the top half. Most of the corrosion inside the duct occurred where the strands had rubbed against it. This is shown in Figure 5.25. The outside was more damaged, with widespread pitting over the same intervals as the area loss.

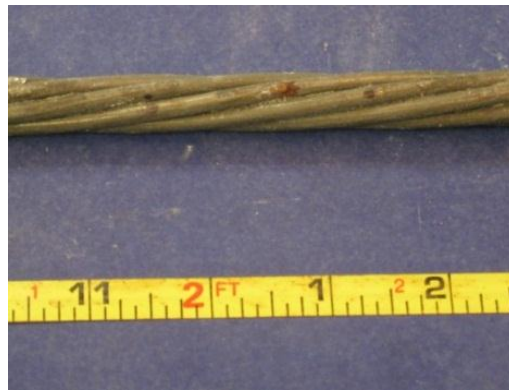
***Figure 5.26: Specimen T.2, North Duct Strand Showing Pitting Near Midspan***

One strand in the north tendon was slightly damaged. The outer wires were either undamaged or lightly discolored on all intervals, and the inner wire had light corrosion or discoloration on most intervals. At the location of the live end transverse surface crack, the inner wire of this strand showed some corrosion which could not be removed with a scouring pad. The other two strands in the north duct were substantially more damaged. Several outer wires on both strands had spots of surface corrosion which could not be scrubbed away and localized pitting at midspan, with discoloration or light corrosion over the remaining intervals (see Figure 5.26). The inner wires of these strands were also more damaged, with flecks of light to moderate corrosion over most of their length. Overall, the corrosion ratings were highest at the location of transverse surface cracks and consistent over the rest of the tendon.

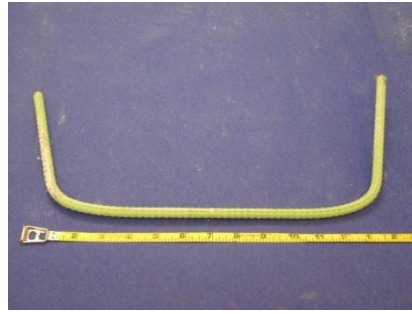
**Stirrup**

Damage to the stirrups was light to moderate. For five of the seven stirrups, all corrosion could be removed with a scouring pad. Most stirrups showed some discoloration and light corrosion at their bends and at the locations where the ducts were tied. Stirrup #4 was most damaged. It had pitting at two tie points on its outer surface. In general, corrosion ratings were highest for stirrups near midspan and lowest for those at the ends of the autopsy region. A typical stirrup is pictured in Figure 5.27. Stirrup corrosion ratings are shown in Figure 5.28 and summarized in Table 5.7.

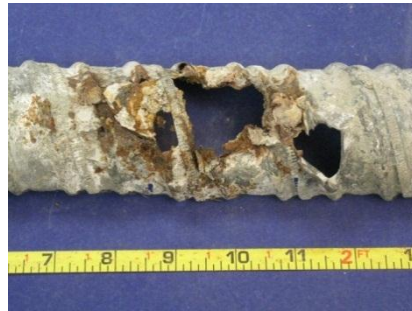
**Top of South Duct**

Overall, the south duct was less damaged than the north duct. There was some area loss on top of the duct in the area between transverse cracks, but it amounted to far less cross-sectional area and only extended over a few intervals. Typical damage to the top of the duct is shown in Figure 5.27. The outside of the top portion also showed localized severe pitting and corrosion around midspan. Inside, the corrosion was less extensive, with pitting occurring in the intervals nearest to the area loss. The corrosion inside the south duct also indicated the presence of a large void, albeit smaller than the north duct. The bottom of the south duct had some localized pitting, corrosion, and discoloration on its outside over the same intervals as the top of the duct. Inside, the damage occurred over the same region but to a lesser extent. Duct corrosion ratings are shown in Figure 5.28 and summarized in Table 5.7.

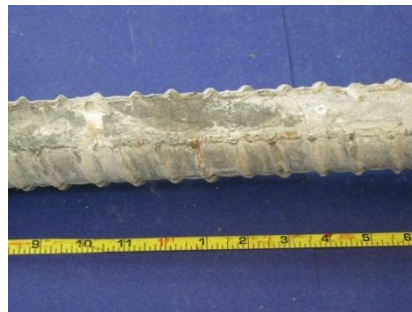
**South Grout**

The south tendon grout had voids over most of its length. The largest void extended from near the live end of the grout to just past midspan (see Figure 5.27). This void was approximately 1.25 inches wide. The grout was moderately stained with corrosion products over this region, with the most intense discoloration occurring at midspan. The top of the grout also showed craze cracks in the middle of this large void region. On the dead end half of the specimen, voids were also present, but these were confined to the upper flutes of the duct and were approximately 0.5 inches wide. The grout vent at midspan left a deep impression in the grout. This may indicate that the grout vent was not properly seated at the top of the duct and consequently slipped downward, possibly interfering with the flow of grout through the tendon. The underside of the south tendon grout was poorly consolidated. Like the north grout, there was at least one strand exposed over the entire length of the tendon. Chloride levels were much lower in the south duct grout but still above the corrosion threshold. The maximum chloride concentration was 0.094% at midspan. Chloride content for grout in both tendons is given in Figure 5.28. Peak chloride content occurred at the location of the area loss, suggesting that chlorides entered there first and dissipated outward through the voids.

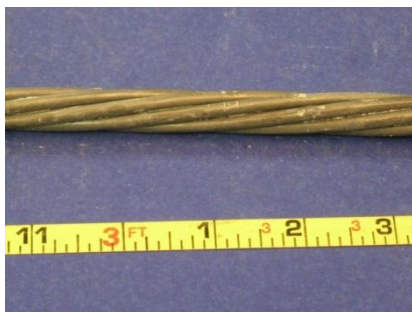
**Strand**

The three south duct strands all showed similar levels of damage, and were more severely corroded than the north duct strands. Spots of light to moderate corrosion occurred at the location of the live end transverse surface crack on all three strands, with light localized corrosion and discoloration occurring on other intervals. The inner wires were uniformly damaged, with light surface corrosion occurring on almost all intervals. Corrosion ratings in the south duct strands showed peaks at crack locations, and were uniform and higher than the north duct strands. A typical strand and inner wire are shown in Figure 5.27. Strand corrosion ratings are shown in Figure 5.28 and summarized in Table 5.7.

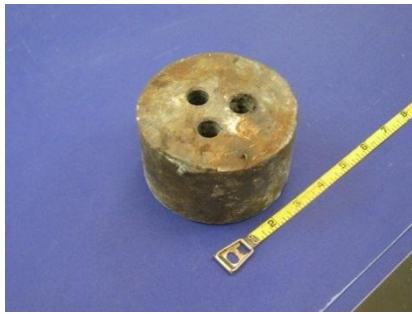
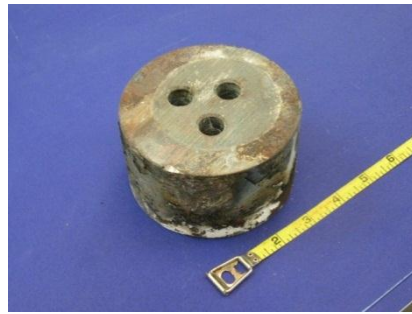
***Figure 5.29: Specimen T.2 Anchorages and Anchor Heads***

The epoxy applied to the anchorages before casting the pourback was largely intact. The epoxied surfaces were mostly either undamaged or lightly discolored. The bottom surfaces and outside edges of both bearing plates experienced some localized moderate corrosion. The duct tape used to seal the joint between the ducts and bearing plates was completely intact. Some moderate corrosion was later found on the area of the bearing plate which had been covered by the duct tape. Upon removal, the anchor heads showed uniform moderate corrosion. The area which had been covered by grout was merely discolored. North and south anchorages and anchor heads are shown in Figure 5.29.

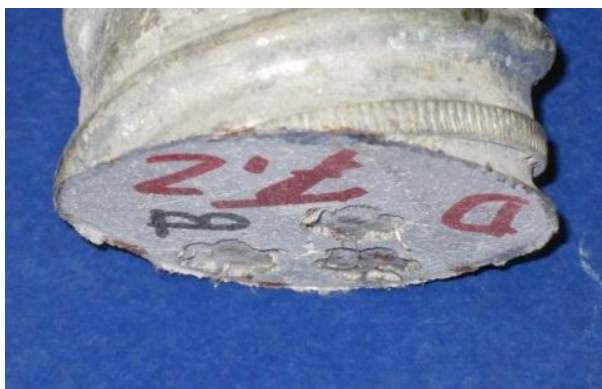
**Figure 5.30: Specimen T.2, Debonded Strands in South Anchorage**

The south tendon strands shortened by approximately 0.1 inches after the anchorage had been removed from the specimen, as shown in Figure 5.30. Strands in both tendons experienced light to moderate corrosion at their exposed ends and more localized light corrosion or discoloration elsewhere. The extent of corrosion was mostly uniform between the outer wires and inner wire of each strand. Overall, corrosion ratings were higher for the north tendon strands than for the south. The wedges showed some surface corrosion but were substantially intact. The appearance of a typical strand, with and without wedges, is shown in Figure 5.32. Corrosion ratings for the anchorage zone strands are shown in Figure 5.31 and summarized in Table 5.8.

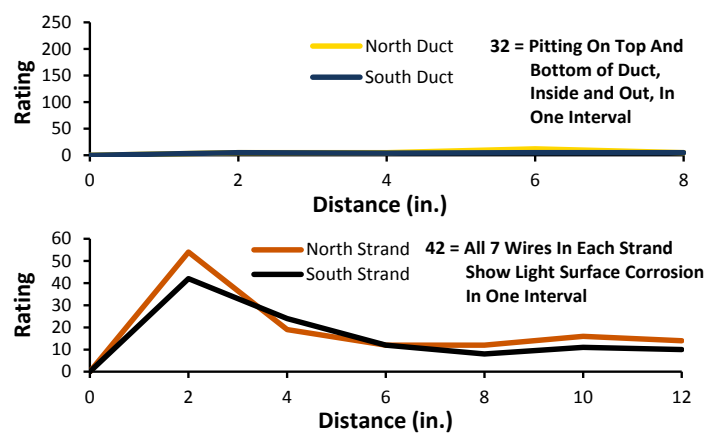
**Figure 5.31: Specimen T.2 Anchorage Corrosion Rating Plots**

The anchorage zone ducts were only mildly damaged. Some extremely localized pitting and surface corrosion was found on both ducts in the area which had been covered with duct tape. Light corrosion was also found on the inner top surface of the ducts, indicating the presence of small voids there. Otherwise, all surfaces of both ducts showed mild discoloration or extremely localized corrosion. North and south anchorage zone ducts are shown in Figure 5.32. Corrosion ratings for the anchorage zone ducts are shown in Figure 5.31 and summarized in Table 5.8.

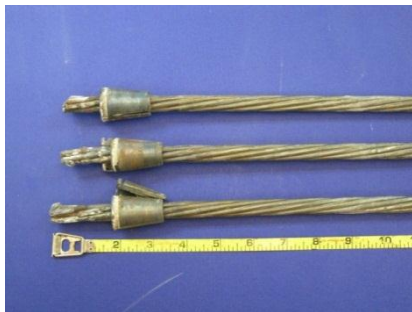
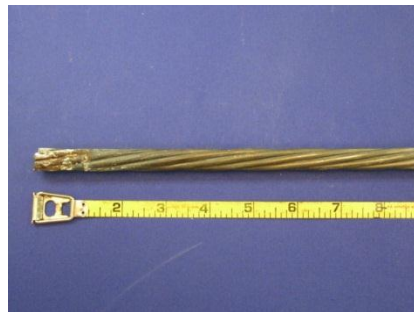
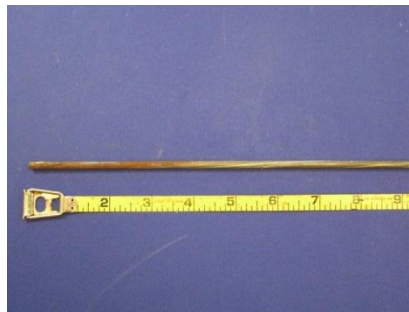
**Figure 5.32: Specimen T.2 Anchorage Region Elements**

The grout from both tendons fractured during removal. Thus, the extent of cracking could not be determined. The top surface of both grouts was covered with small, elliptical voids which had formed inside the flutes of the duct. The north grout also had a few very small stains near the anchorage-duct connection. The north grout showed evidence of segregation, as shown by a light gray color near the anchor head and a darker gray toward the inside of the specimen. North and south grouts are shown in Figure 5.32.

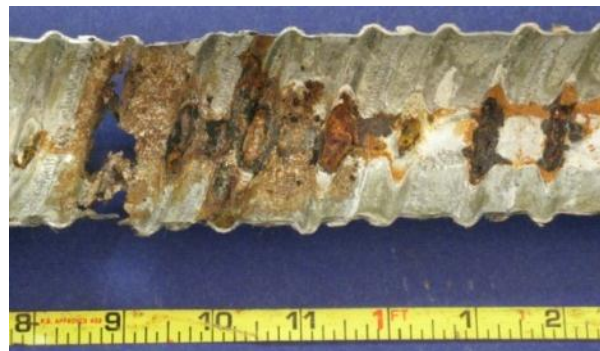
Both galvanized steel ducts showed severe localized corrosion damage. The outside top half of the north duct experienced area loss and extensive pitting over several intervals near midspan and its quarter points, as shown in Figure 5.38. Inside the top half, pitting and area loss were just as severe. Where the duct was still intact, corrosion and discoloration were visible in the uppermost flutes of the duct. This suggests that small voids were present in the grout. The void appeared to be continuous between 8 inches and 22 inches from the live end of the autopsy region. Corrosion may have initiated at midspan and traveled outward over this void (see Figure 5.35). The bottom half of the duct was much less damaged overall. While pitting and some slight area loss occurred on the outside at the duct's quarter points, discoloration and corrosion were less widespread in the other areas of the duct. Inside, the bottom half of the duct was widely discolored but only showed small areas of pitting near the quarter points. The pattern of the discoloration on the bottom of the duct suggests that the grout was cracked over much of its length and that at least two of the strands had rubbed against it during its life. Among large areas of discoloration, some regions of the inside even showed the characteristic sheen of new metal.

***Figure 5.35: Specimen 1.2, Area Loss and Large Void on Top Inner Surface of North Duct***

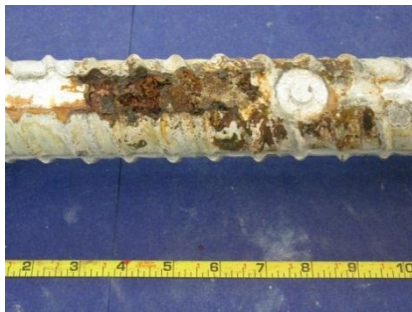
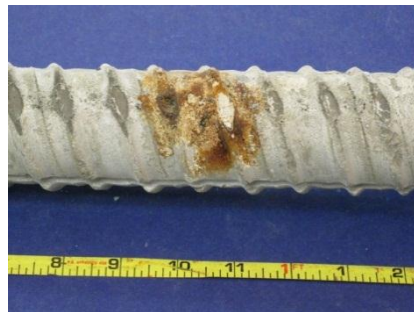
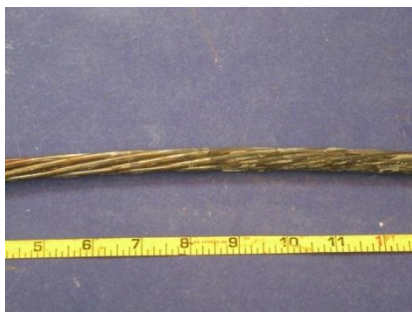
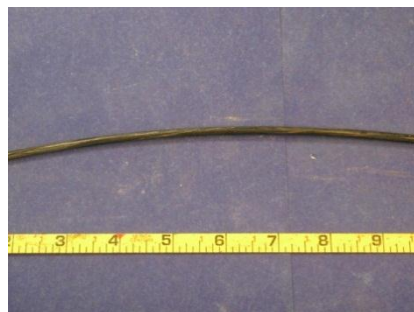
**Figure 5.38: Specimen 1.2 Main Autopsy Region Elements**

Damage to both longitudinal bars was minor. Spots of discoloration and light surface corrosion occurred on the top and bottom of both bars at the locations where stirrups were tied. This damage occurred uniformly along the length of both bars. Neither bar was perceptibly more damaged than the other. The corrosion rating was highest 28 inches from the live end of the autopsy region. Typical longitudinal bar corrosion for this specimen is shown in Figure 5.38. Longitudinal bar corrosion ratings are shown in Figure 5.39 and summarized in Table 5.9.

corrosion and discoloration were most prevalent at the stirrups' bend locations and where the ducts had been tied, as shown in Figure 5.38. Stirrup #2 was most severely damaged. It had pitting on both the top and bottom of its horizontal portion over one interval. The three stirrups with the highest corrosion ratings were located underneath each of the three transverse cracks on the specimen surface. Stirrup corrosion ratings are shown in Figure 5.39 and summarized in Table 5.9.

The south tendon grout was also cracked transversely every few inches along its length. Small voids were found on the top portion of the grout and appear to have formed within the top flutes of the duct, as shown in Figure 5.38. These voids were approximately 0.5 inches wide. Staining occurred at the locations corresponding to area loss and pitting of the surrounding duct. This staining permeated from the top of the grout down to the level of the strands (see Figure 5.36). Localized yellow-orange discoloration spots were also observed on all sides of the grout. Some portions of strand were exposed on the bottom of the grout, but not nearly to the extent of the north grout. The south grout was extremely well-consolidated compared to the north grout. Considerably more effort was required to crack it in order to expose the strands within. Maximum chloride concentration in the grout was 0.112% at midspan. Measurements taken at 8 and 32 inches from the live end were approximately at the threshold for corrosion. Chloride content for grout in both tendons is given in Figure 5.39.

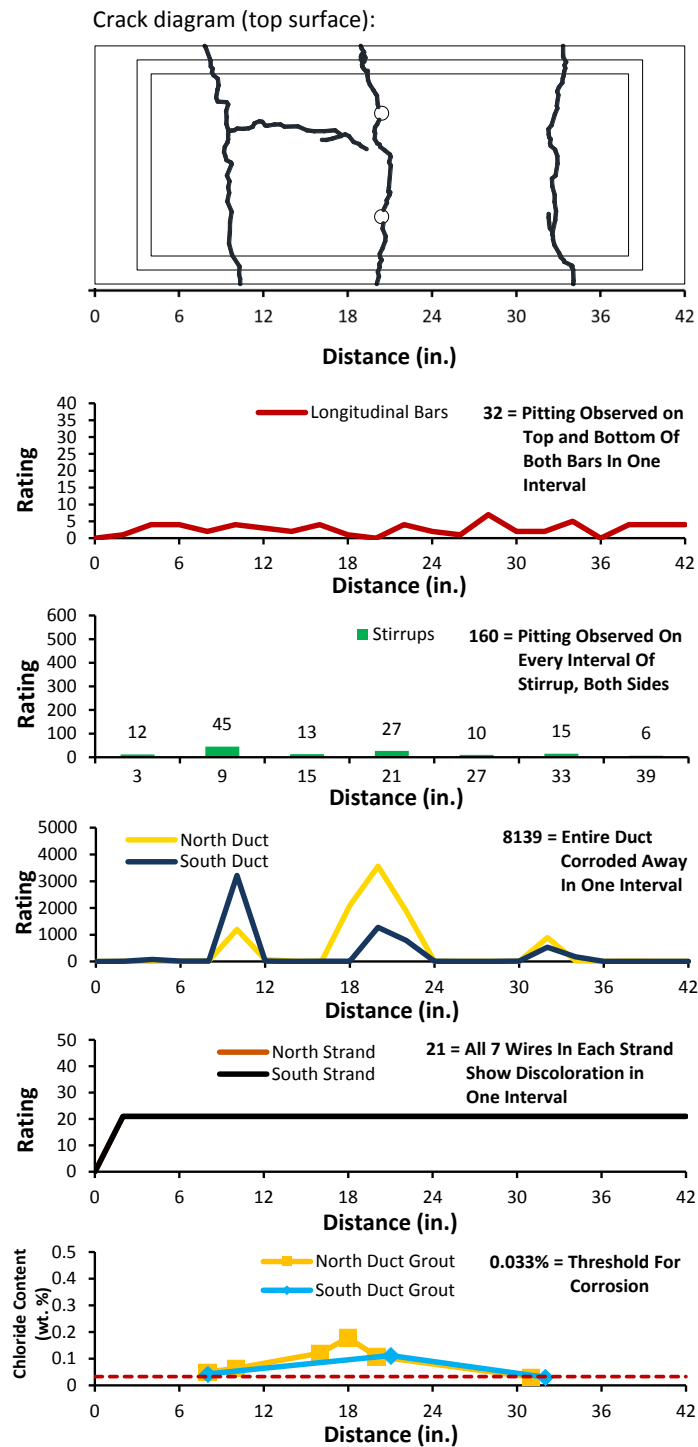
Figure 5.39: Specimen 1.2 Crack Map and Corrosion Rating Plots

intact at the time of autopsy. These cracks were located roughly at the quarter points of the specimen. Their average width was 0.02 inches. One longitudinal crack extended from near the middle transverse crack to the live end transverse crack approximately six inches from the north edge of the specimen, and its width was 0.004 inches. The specimen also had a crack which extended from the bottom corners of the live end anchorage pourback nearly to the re-entrant corner of the corbel at the bottom of the specimen. This crack had formed long after the live load was applied. As a result, it was not sealed with mortar. After a period of wet weather, leakage was observed from this crack (see Figure 5.33). Some slight separation was observed at the joint between the live end anchorage pourback and the rest of the specimen, suggesting that some shrinkage had taken place. Crack width data is shown in Figure 5.34, and the crack diagram is shown in Figure 5.39.

The south duct was similarly damaged. Its area loss was more extreme than the north duct at the live end quarter point, less extreme at midspan, and roughly comparable to the north duct at the dead end quarter point. Corrosion damage to the outside portion of the top half of the duct was extremely localized. Pitting and area loss occurred over only a few intervals near each quarter point and midspan. The remainder of the duct was only slightly discolored or lightly corroded, as shown in Figure 5.38. Inside, damage was similar. Discoloration on the top of the duct suggests the presence of small voids within its flutes. Unlike the north duct, these small voids did not appear to be continuous at any point along the duct. The outside of the bottom half had minor area loss at the quarter points along with extensive corrosion and pitting over most other intervals. Inside, there was some isolated light to moderate corrosion near the quarter points as well as at spots where the strands had rubbed on the duct. Overall, the discoloration within both ducts was much darker than expected. This may be due to the dark patina of the copper-clad strand in this specimen. Duct corrosion ratings are shown in Figure 5.39 and summarized in Table 5.9.

Both tendon grouts had similar chloride distributions. However, the north tendon grout had a long continuous void on its top surface, while the south did not. This means that chlorides are transported through strand interstices and grout voids at approximately the same rate, achieving the uniform distributions shown in Figure 5.39.

distinctive orange color of copper was even visible in spots at the ends of some strands. At the ends of several strands, a bright red color was observed, as shown in Figure 5.37. This may have been a phenomenon known as dezincification. This is a type of selective corrosion in which zinc leaches out from copper alloys and oxidizes, forming a characteristic red color<sup>22</sup>. The zinc content of the copper-clad strand is unknown. Transverse lines were visible on many outside wires of the strands in both ducts. These lines coincide with the locations of cracks in the north duct grout. Strand corrosion ratings are shown in Figure 5.39 and summarized in Table 5.9.

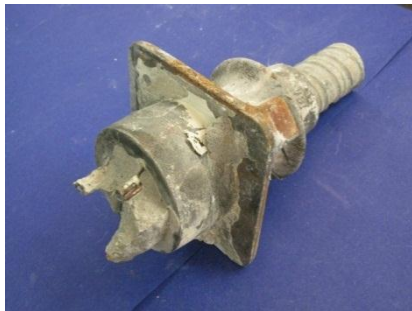
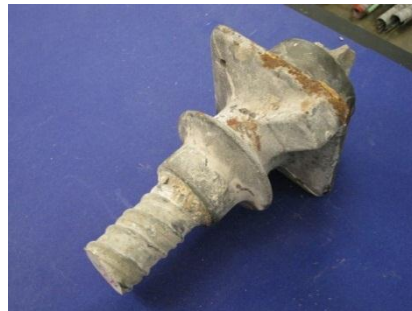
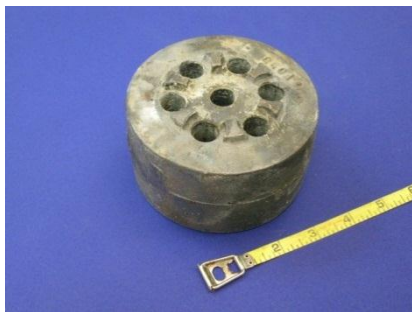
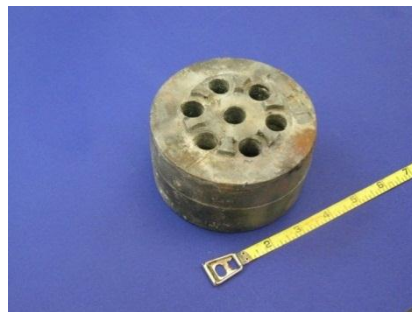
***Figure 5.40: Specimen 1.2 Anchorages and Anchor Heads***

Corrosion damage to the both anchorages was mild. Although the epoxy used to seal the anchorages prior to pourback had been scraped off during autopsy, the exposed surfaces of the bearing plates and anchor heads were mostly corrosion-free. There were some isolated spots of discoloration and light corrosion, but these represented only a small fraction of the exposed area of the bearing plates. The non-exposed surfaces of the bearing plates were dotted with isolated discoloration and light corrosion. Damage was most severe to the bottom edge of the bearing plates and grout vents, which experienced some moderate corrosion. Overall, the south anchorage was slightly more damaged than the north anchorage. Both anchor heads were completely intact. The north anchor head was only slightly discolored in spots, while the south anchor head experienced some localized moderate corrosion on its inside edge. The north and south anchorages and anchor heads are shown in Figure 5.40.
